## **NILAN DAMS**

## Fact Sheet

## **PROJECT DESCRIPTION**

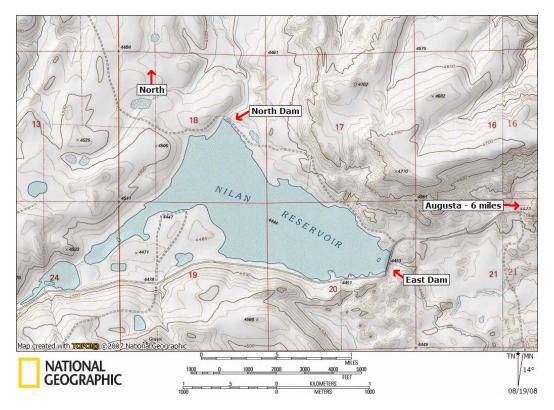
New Outlet Terminal Structure at North Dam

- ♦ Several major repairs were completed on the East Dam in 1999 to repair sinkholes that developed along the upstream toe. A new outlet terminal structure and drain system was installed at the north dam in the spring of 2008.
- The project meets or exceeds all current dam safety standards.
